Active Faults in Southeastern Harris County, Texas

Uel S. Clanton

Environmental Geology Vol. 1, pp. 149-154 © 1975 by Springer-Verlag New York Inc.

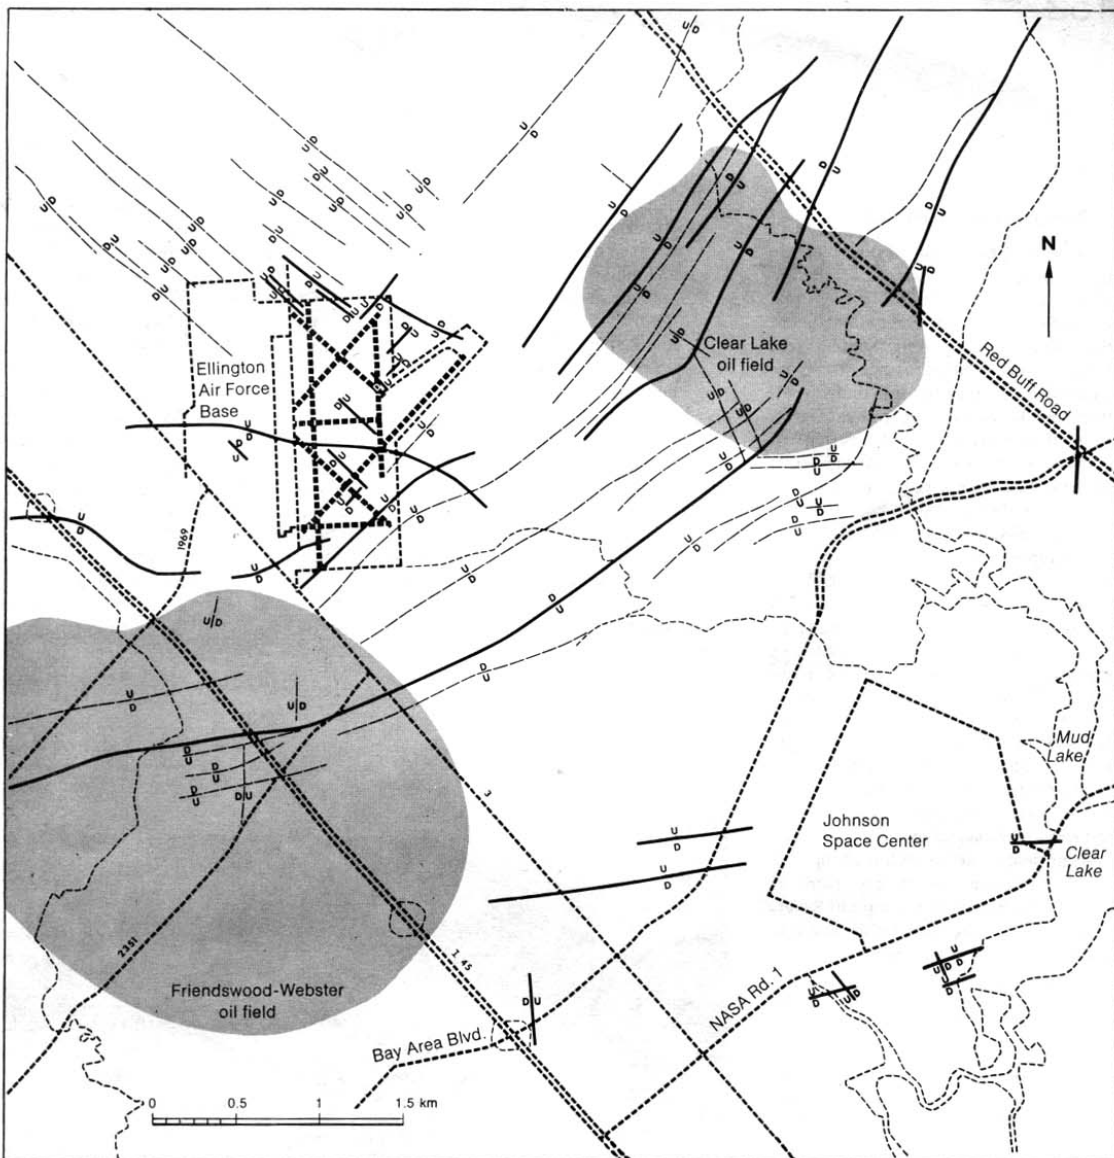
Figure 1. Faults plotted on a photobase of NASA-JSC near-infrared photo 175/145, roll 69, frame 148. Solid lines mark faults associated with structural damage to roads, buildings, and runways. Dashed lines represent straight-line scarps associated with inactive faults or faults that are active but, because of location, cause no structural damage. Extensive sag ponds occur along both types of faults.

Fig. 1 is a map covering about 26 sq km in southeastern Harris County. The information used to prepare the map is from black-and-white aerial photographs taken in 1956, 1965, 1969, 1972, and 1973; color IR aerial photographs taken in 1970, 1972, and 1973; and color aerial photographs taken in 1971 and 1973. In addition, all features have been field checked. The solid lines indicate locations where the photolineations coincide with failures in roads, buildings or runways, and the fault is considered to be active because of the existing structural damage. The broken lines indicate straight-line scarps that represent fault-

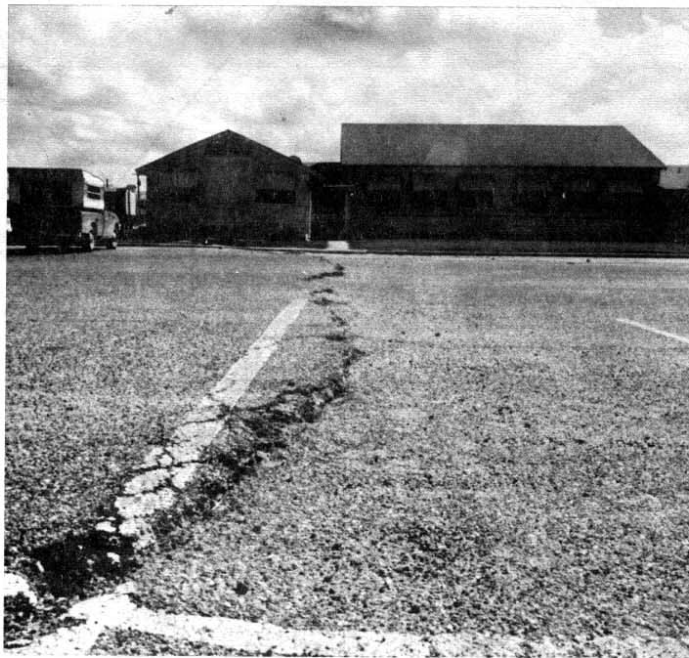
Figure 2. Sinuous fault scarp crossing a parking lot near Building No. 743 (EAFB). The variation in height of the fault scarp on the parking lot and in the street and curb reflects different construction dates. The street and curbs have been patched to repair the damage.

Fig. 2 shows a sinuous fault scarp on a parking lot on EAFB. The difference in height of the scarp on the parking lot and the offset in the street and curbs is the result of a difference in construction dates. This fault has a 1 m scarp in the pastures adjacent to the base but only about 30 to 45 cm on the base. This difference in elevation suggests that the fault was active prior to the construction of the base.

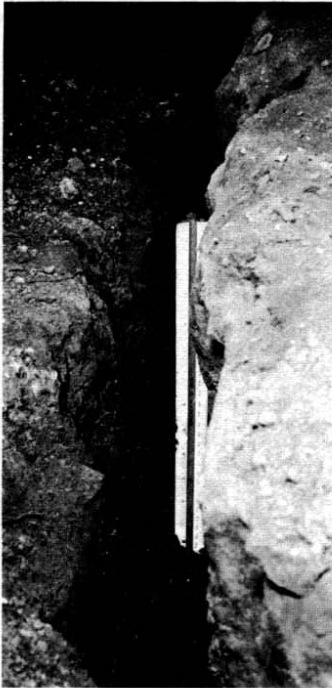
Figure 3. Building No. 732 at EAFB has a pier-and-beam foundation that has protected this fault scarp from erosion since 1942. The fault is a sinuous fissure 8 to 10 cm wide open to a depth of about 35 cm. Below this depth the cavity has been filled.

short sections of this fault scarp from erosion since 1942. In this protected environment the fault occurs as an open sinuous fissure (Fig. 3) with not only the usual vertical displacement but also a definite horizontal separation or heave. The fissure is 8 to 10 cm wide and open to a depth of about 35 cm, below this depth the cavity has been filled with rubble from the walls.

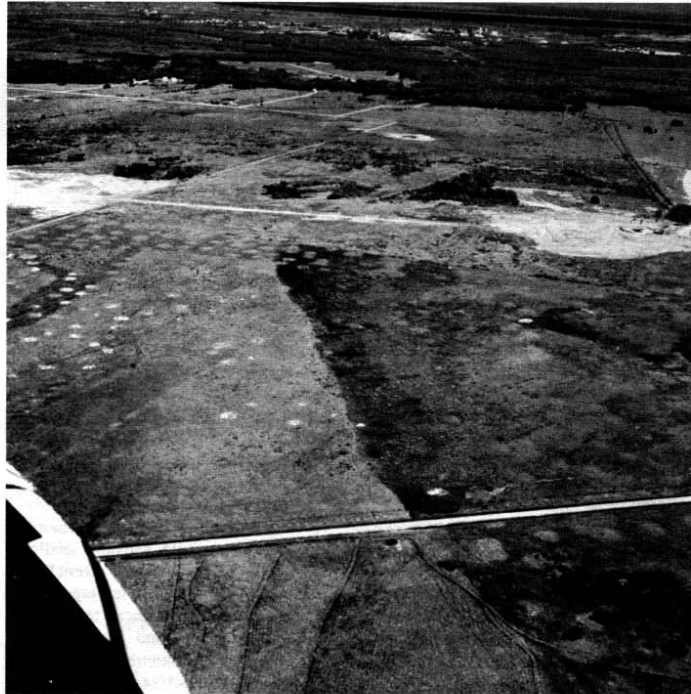
Figure 4. A copy of a color IR photograph taken at an altitude of about 300 m. The upthrown side of the fault is typically lighter in color. The more luxuriant vegetation, wet ground, and occasional sag ponds give the downthrown side a darker color. The apparent abrupt termination of the fault at the fence line is an illusion caused by a difference in land use. The scarp can be traced northeastward for another kilometer.

The fault shown in Fig. 4 is part of the complex graben that connects the Webster-Friendswood and Clear Lake oil fields. In some areas the fault plane appears to be a zone of high permeability, allowing shallow artesian ground water to reach the surface to form sag ponds. In addition, the differential movement modifies the drainage pattern and surface runoff tends to accumulate on the

dowthrown side. Soils of the downthrown side of the fault are typically darker than those of the upthrown side. This darker color is the result of the higher moisture content of the soil and the difference in vegetation. Bulrush, spike rush, arrowhead, bog rush, and other typically aquatic or wet-land plants tend to dominate the vegetation. In addition, where one fault in the graben crosses a new man-made drainage channel, water flows from a spring in the channel wall.
